**Flood Control Project Maintenance
Levee Inspections**
LMA District Cover Sheet
Spring 2009 Levee Inspection Results

Reclamation District No. 2094

Levee Inspection Report By Mile - Spring 2009

Waterway	Bank	Unit Miles	Inspection Start/End	Inspector
Unit No. 01 San Joaquin River	Right	2.80	05/14/2009 05/14/2009	David Pesavento

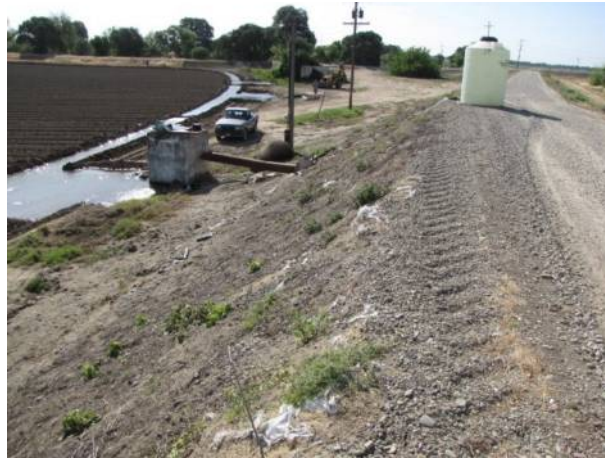
Levee Mile Report Line	5
Start Levee Mile	0.59
End Levee Mile	0.59
Location	Land Side
Category	Earthen Levee
Item	Slope Stability

5	0.59	0.59	Earthen Levee	Slope Stability	LS	A	Repair slope instability. Inspector Comments: District representative requested notation made that the waterward slope of the bank is a gentle slope but the landward slope is steep.	37.768143 ° -121.295829 °	37.768143 ° -121.295829 °	Y	6
6	0.65	0.65	Earthen Levee	Vegetation	LS	A	Remove the wild growth other than native grasses from the levee slopes.	37.767642 ° -121.295063 °	37.767642 ° -121.295063 °	Y	7
7	2.30	2.30	Earthen Levee	Encroachments	CR	M	Equipment	37.752334 ° -121.296322 °	37.752334 ° -121.296322 °	Y	8

View of landward slope. Note how steep the grade is compared to the waterward slope.

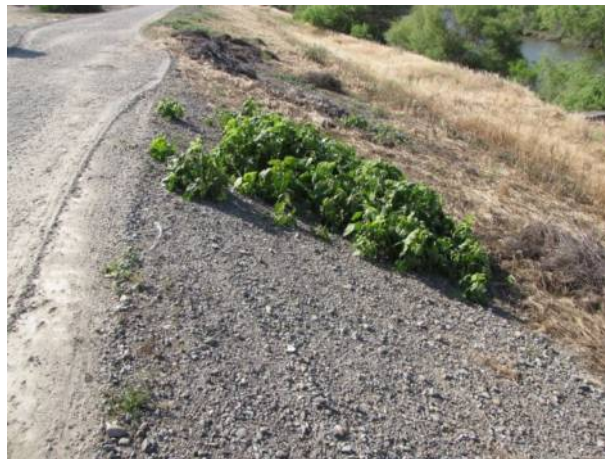
Levee Mile Report Line	5
Start Levee Mile	0.59
End Levee Mile	0.59
Location	Land Side
Category	Earthen Levee
Item	Slope Stability

Waterward slope at same location as previous photo.

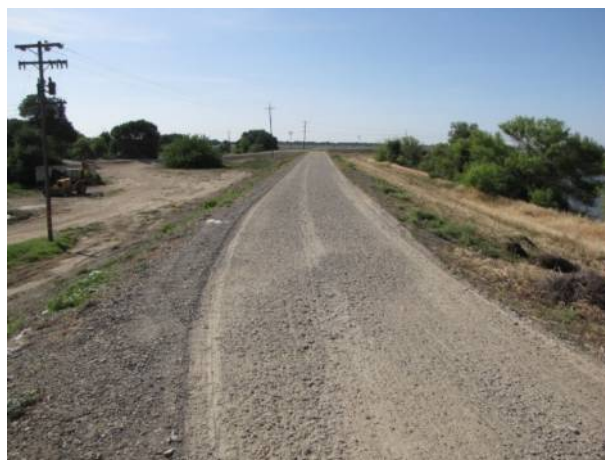
Levee Mile Report Line	6
Start Levee Mile	0.65
End Levee Mile	0.65
Location	Land Side
Category	Earthen Levee
Item	Vegetation

Example of the good vegetation management along the unit.

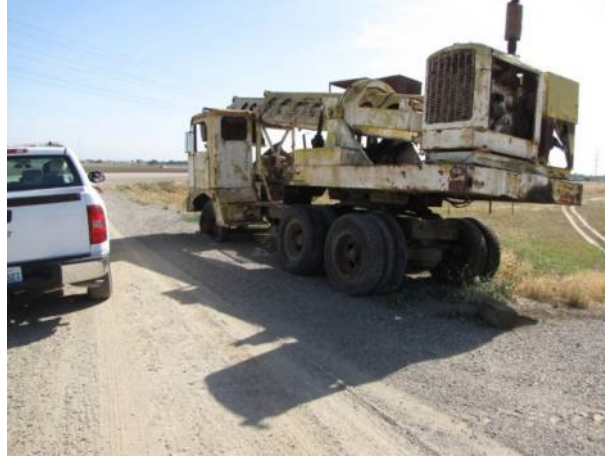
Levee Mile Report Line	7
Start Levee Mile	2.30
End Levee Mile	2.30
Location	Crown
Category	Earthen Levee
Item	Encroachments

Crane parked on waterward sholder of levee crown.

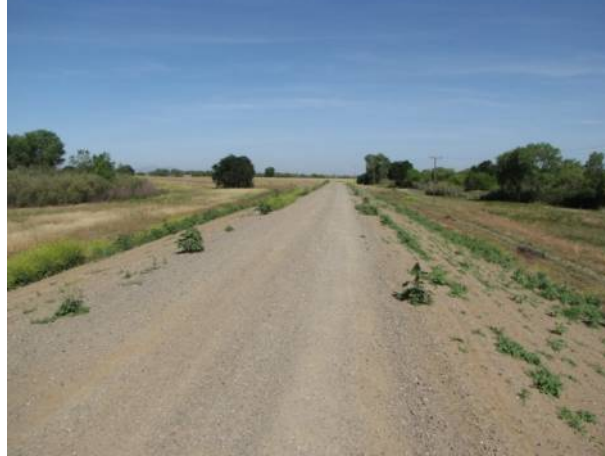
Levee Mile Report Line	1
Start Levee Mile	0.06
End Levee Mile	0.06
Location	Crown
Category	Earthen Levee
Item	Vegetation

LMR Line	Levee Mile		Category	Item	Location *	Rating **	Action/Comment	GPS Latitude/Longitude		Photo	Issue
	Start	End						Start	End		
1	0.06	0.06	Earthen Levee	Vegetation	CR	A	Control annual grass and weeds on the levee slopes and easements.	37.759758 ° -121.300657 °	37.759758 ° -121.300657 °	Y	1

Example of good vegetation management along this unit.
